NAVAL AVIATION SAFETY CENTER

Reporting Custodian VP-16  
Type of Report AAR Serial No. 1-62  
Date of Occurrence 7-23-62 Acft Model P20-5FS  
Type of Film Coverage MAGNETIC TAPE OF CREW CONVERSATION No. of Reels 2  
TECH. LIB.  
NASC Reel ID No. 11

1	2	3	4	5	6	7	8	9	10	11	12	13	14	15	16	17	18	19	20	21	22	23	24	25	26	27	28	29	30	31	32	33	34	35	36	37	38	39	40	41	42	43	44	45	46	47	48	49	50	51	52	53	54	55	56	57	58	59	60	61	62	63	64	65	66	67	68	69	70
PARTIAL PWR LOSS/FIRE STBD RECIP ENG W/O 4 <sup>th</sup> GCA APPR LOW PASS. AT 250 FT LEVEL FLT PORT PROP FEATHERED. A/C COLL/TREES/GROUND CONTROLLED - BURNED. PILOT FACTOR - FEATHERED PORT PROP VICE STBD.

The primary cause of the accident was personnel error in that the wrong propeller was feathered. This action could have been physically accomplished by either of the pilots or the plane captain.

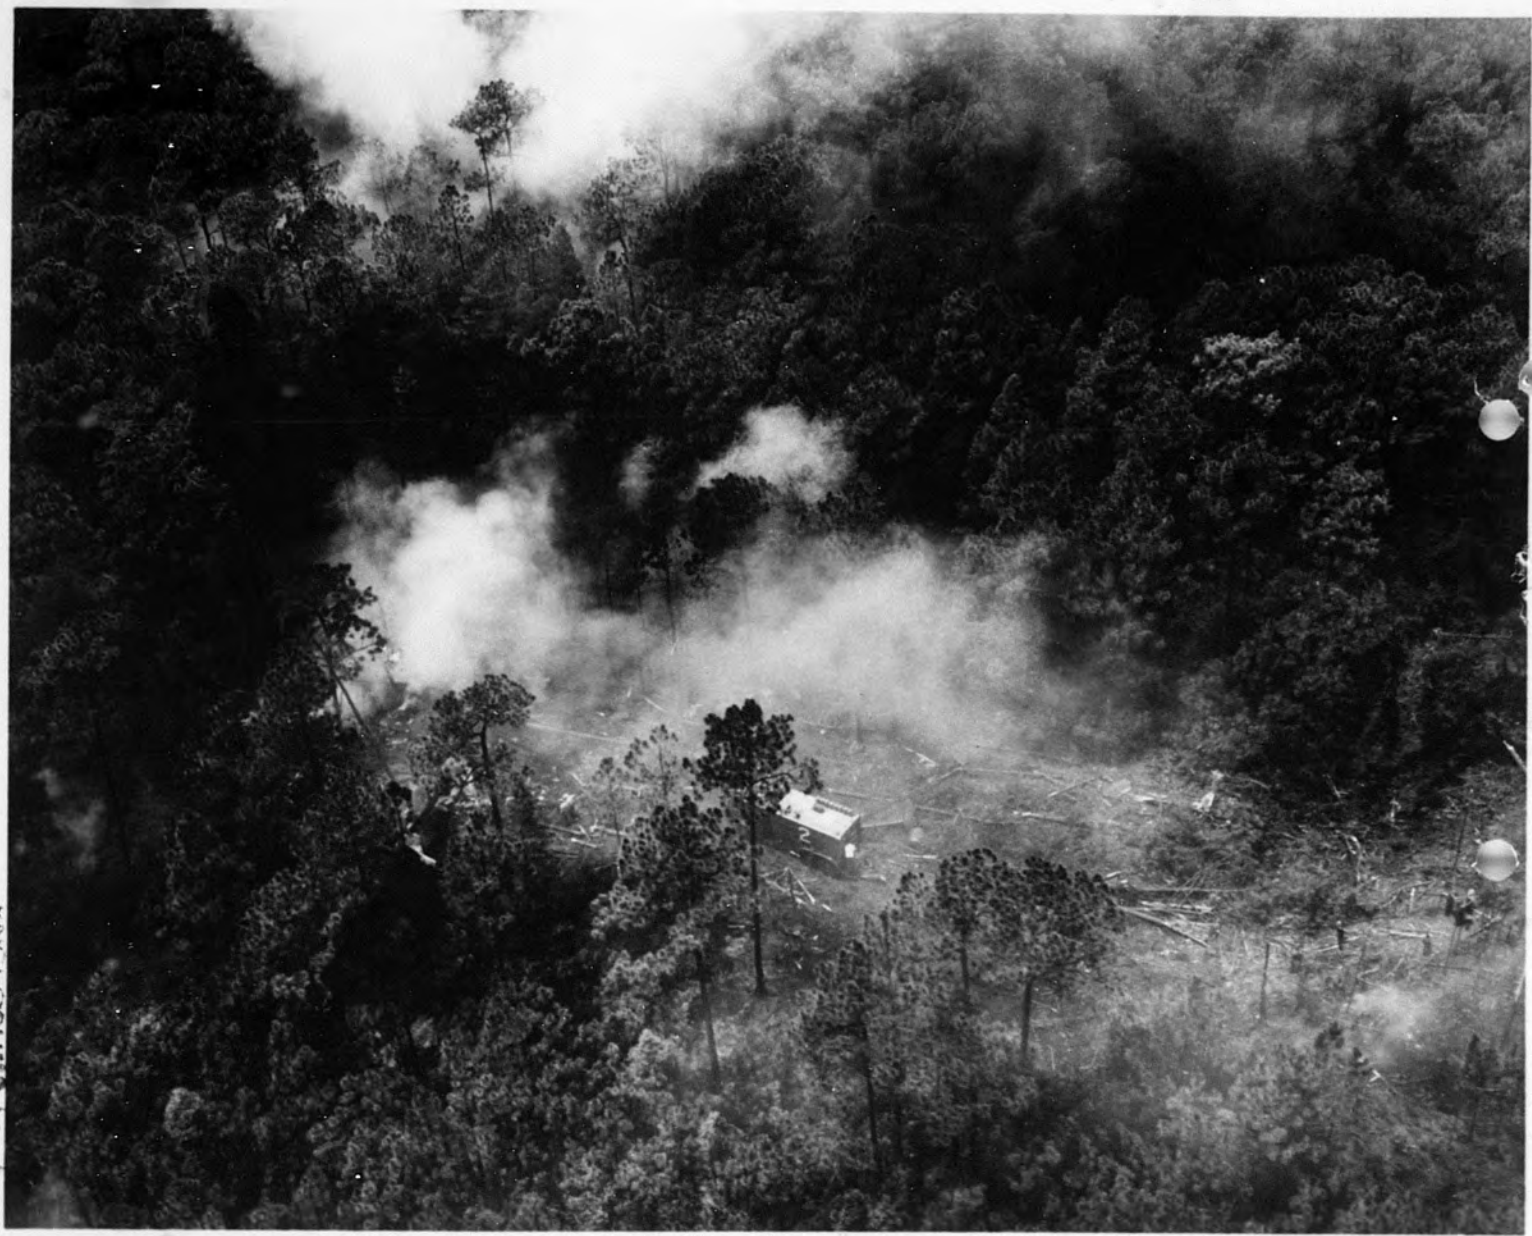
DIAGRAM OF INCIDENT SHOWING WIND, DIRECTION, APPROACH OF  
EQUIPMENT, POSITION OF AIRCRAFT, DISTANCES, ETC.  
(Maps and photographs should be included, if significant)

The progress of all equipment was hampered by the unusually heavy undergrowth encountered at the crash scene, and the rapidly spreading fire through the underbrush. Only one piece of equipment (MB-1) was able to get close enough to the crash scene to discharge its foam. As men arrived they were put to work beating out brush fires with pine limbs until a supply of CO<sub>2</sub>, shovels and brush beaters arrived. The MB-1 suffered extensive damage in traversing the area.

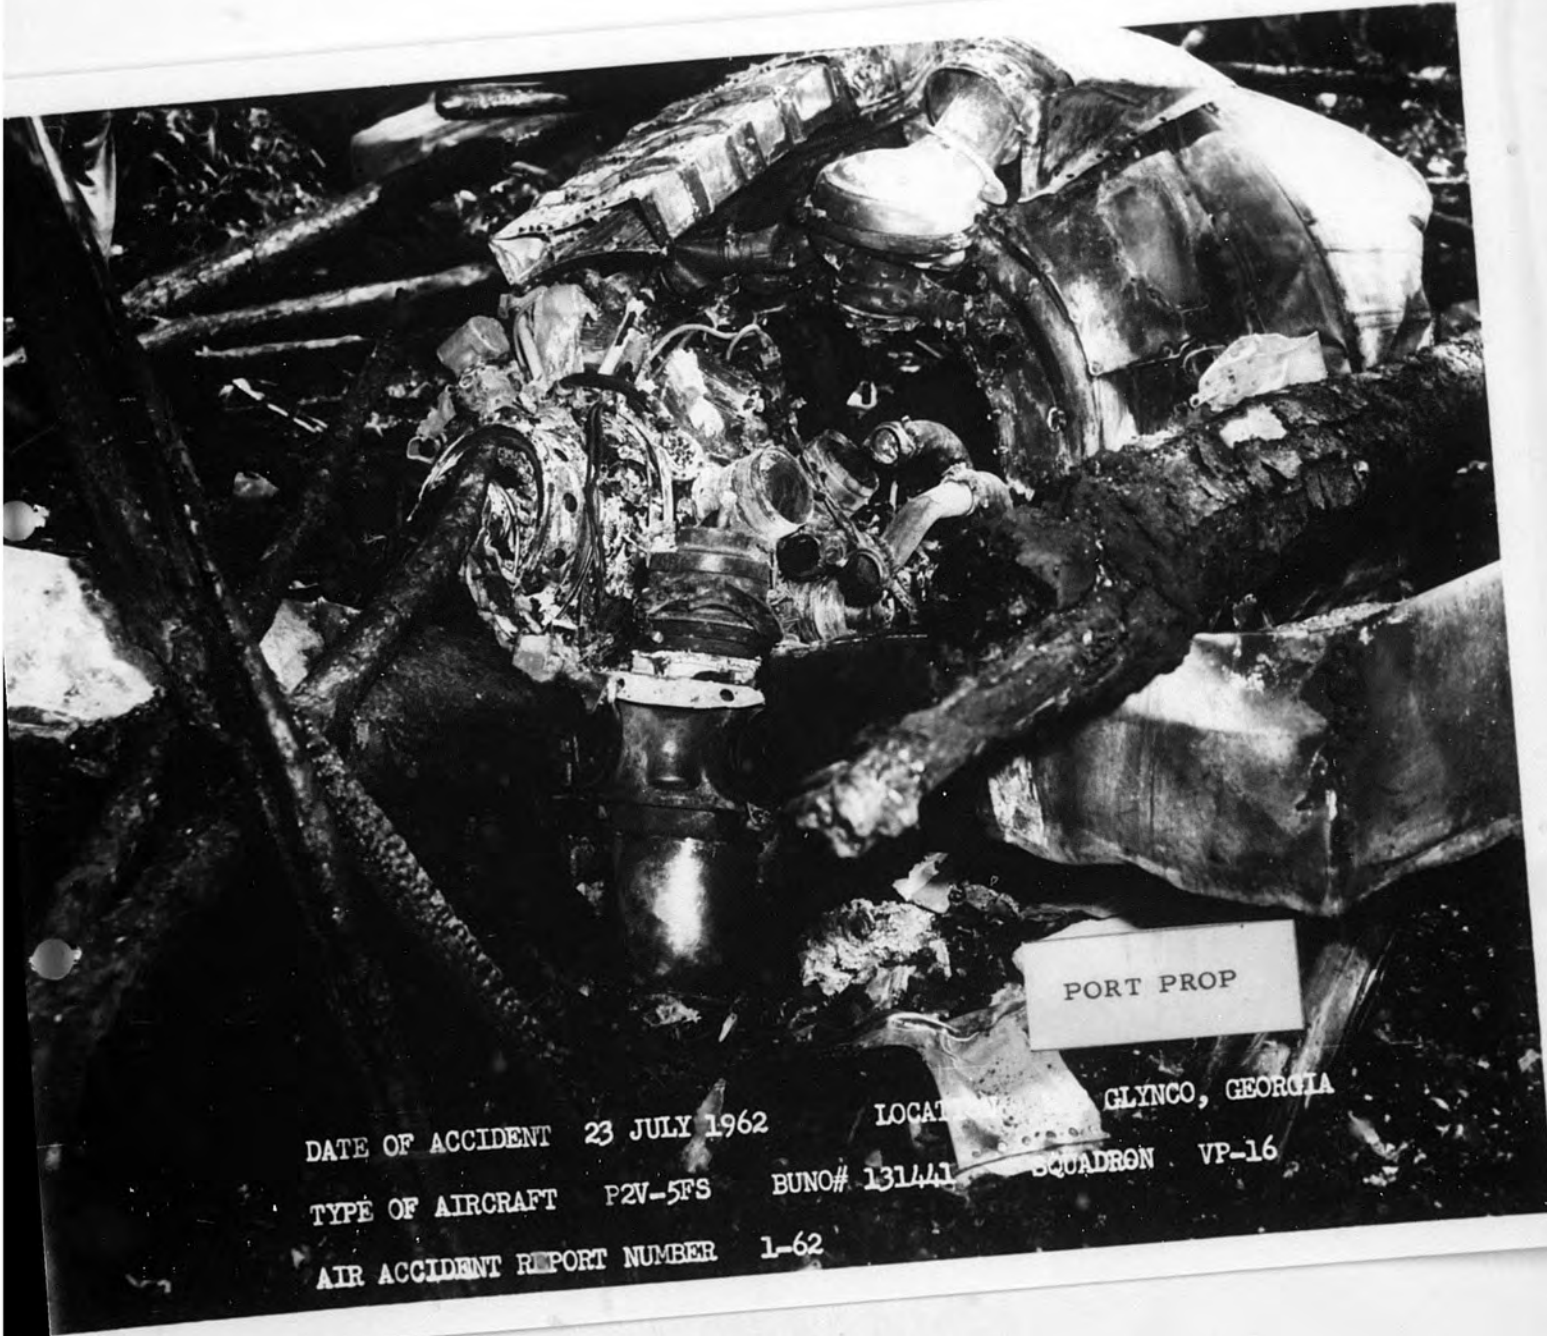
PORT PROP

F. BOTH PROP SHAFTS FAILED FROM BENDING.
